Subject: **Docket No. 50-361**
60-day Post Refueling Outage Reactor Pressure Vessel Head
Inspection Report for San Onofre Nuclear Generating Station,
Unit 2

60-day Post Refueling Outage Reactor Pressure Vessel Head Inspection Report for San Onofre Nuclear Generating Station, Unit 2

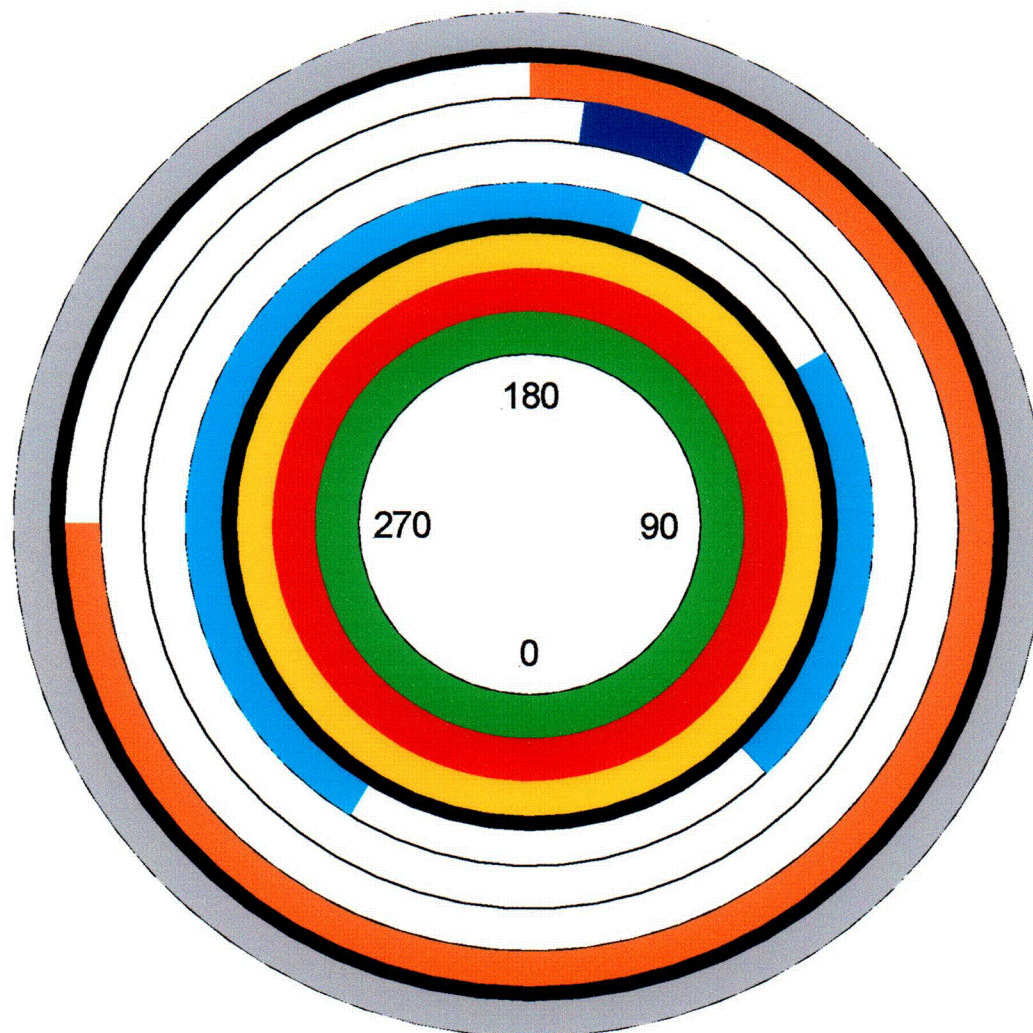
Nozzle 93

Penetrations 93, 97, and 98 had PT indications and penetration 101 had no indications. ICI penetration 93 had three rounded indications on the attachment weld surface that were acceptable per ASME Section XI code acceptance criteria. To ensure that these indications were not connected to subsurface PWSCC, SCE removed approximately 0.040" of material from the weld surface. Final PT revealed that one indication was completely removed and the other two indications remained small, rounded, and code

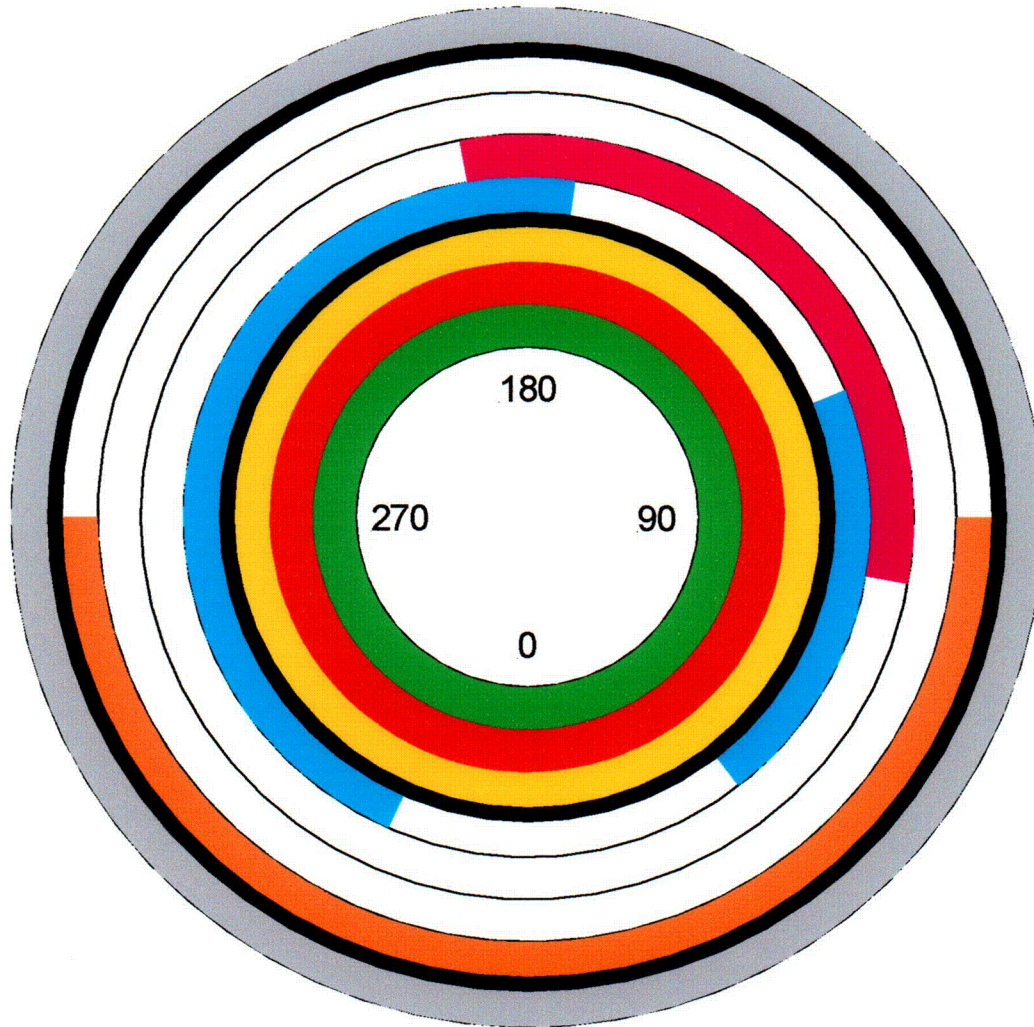
Nozzle 97

acceptable. ICI penetration 97 had two rejectable rounded indications at the interface between the penetration outside diameter and the attachment weld. The PT bleedout was approximately 0.500" in diameter for one indication and approximately 0.125" in diameter for the other indication. One indication was completely removed by grinding 0.125" of material from the surface and the other indication was completely removed by grinding 0.25" of material from the surface. ICI penetration 98 had two linear indications, one on bottom of the penetration and the other on the attachment weld. The indication on the surface of the attachment weld was approximately 0.500" in length. The indication on the bottom of the penetration consisted of a set of seven short linear indications on the edge of the penetration tube. All seven indications crossed through the outside corner of the penetration and were approximately 0.125" in length. All eight of these indications were completely removed by grinding 0.125" of material from the surface. Final PT examination results for ICI penetrations 93, 97, and 98 were acceptable.
